**CONNECTICUT RIVER BASIN
GARDNER , MASSACHUSETTS**

**PERLEY BROOK RESERVOIR DAM
MA 00119**

PHASE I INSPECTION REPORT NATIONAL DAM INSPECTION PROGRAM

JUNE 1980

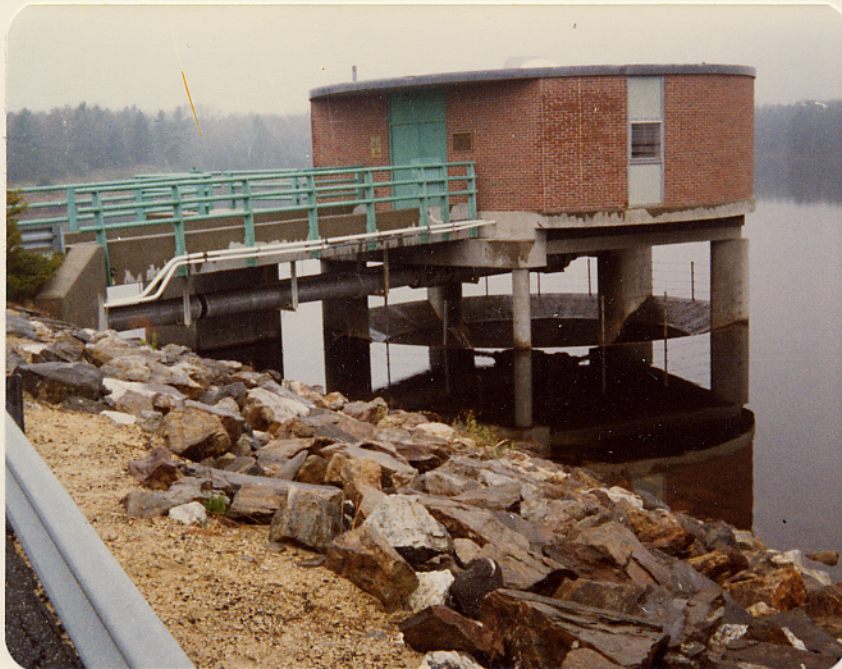
NO. 1 VIEW OF PUMP STATION AND SPILLWAY

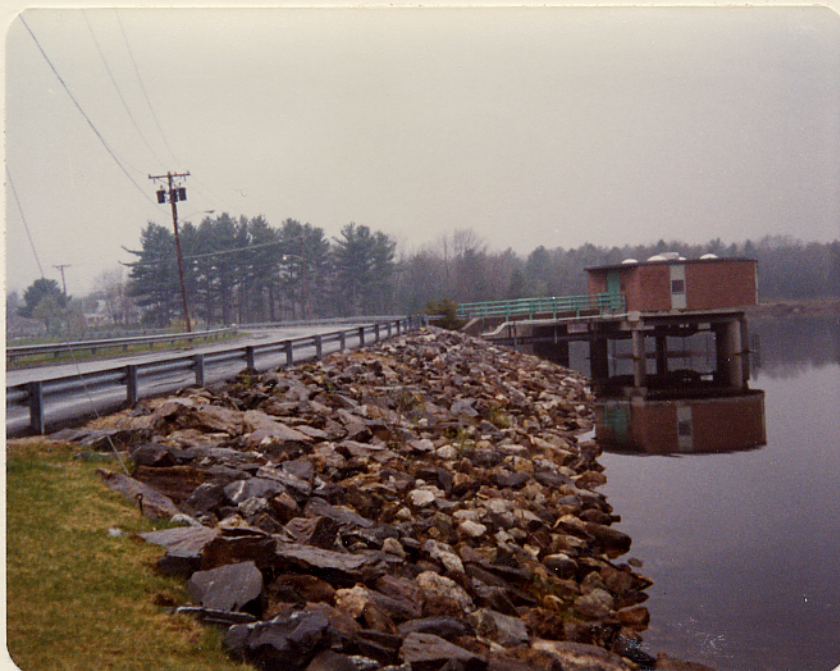
NO. 2 VIEW OF UPSTREAM SLOPE

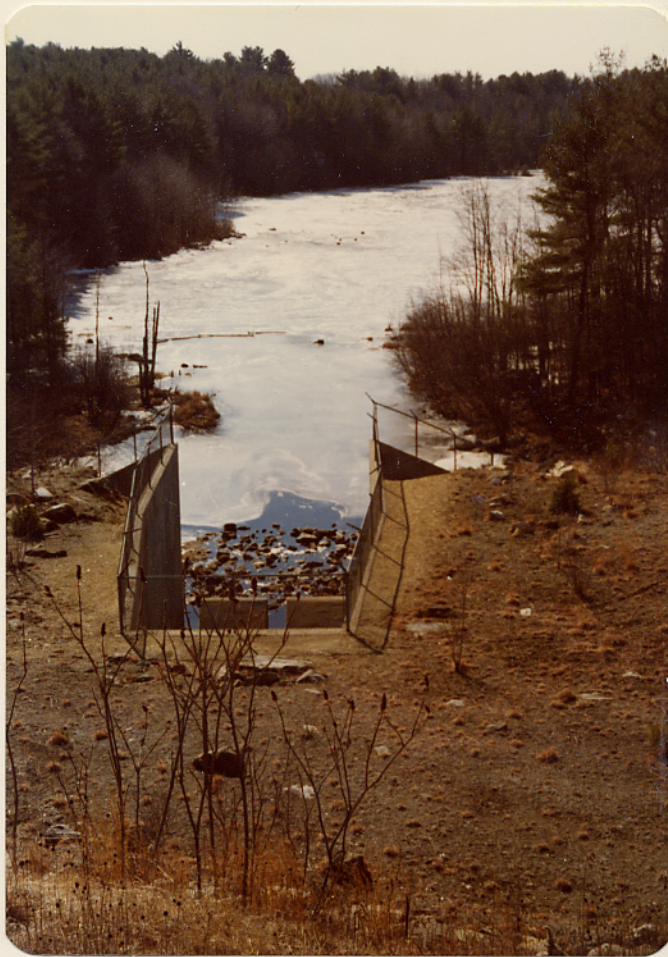
Erosion from surface runoff and trespassing was noted along the wing walls of the stilling basin (see Photo No. 3). The earthfill is unprotected in this area.

NO. 3 VIEW OF DOWNSTREAM CHANNEL

- a. Operating and Maintenance Procedures. It is recommended that the Owner accomplish the following:
 - (1) Place additional earthfill adjacent to the walls of the stilling basin and protect the fill from erosion.

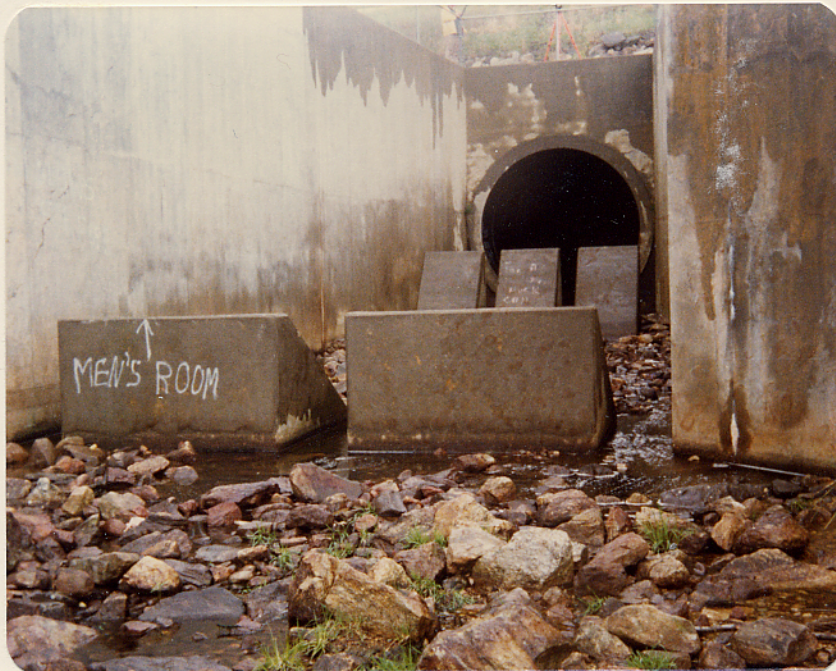
NO. 4 VIEW OF STILLING BASIN

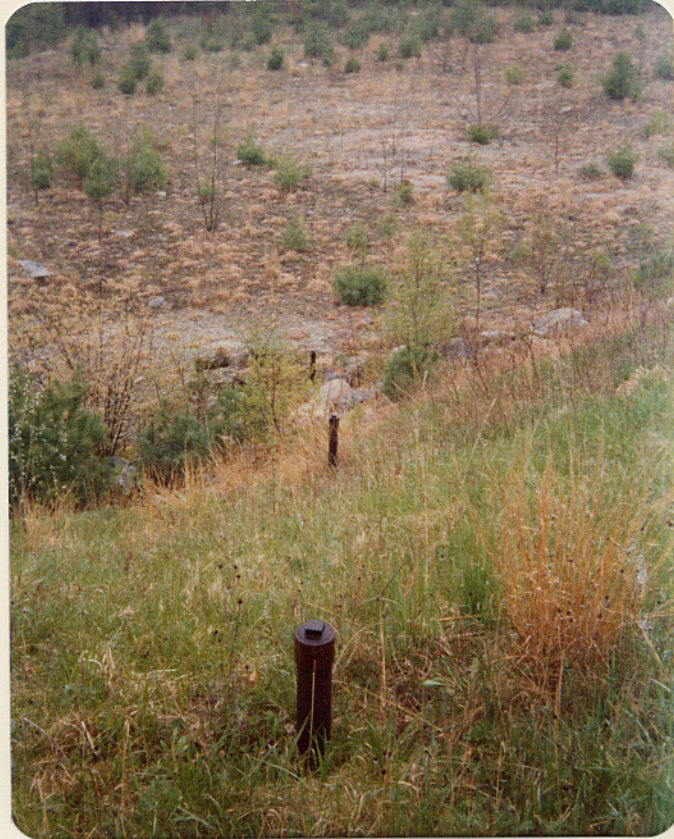
NO. 5 OBSERVATION WELLS ON DOWNSTREAM SLOPE

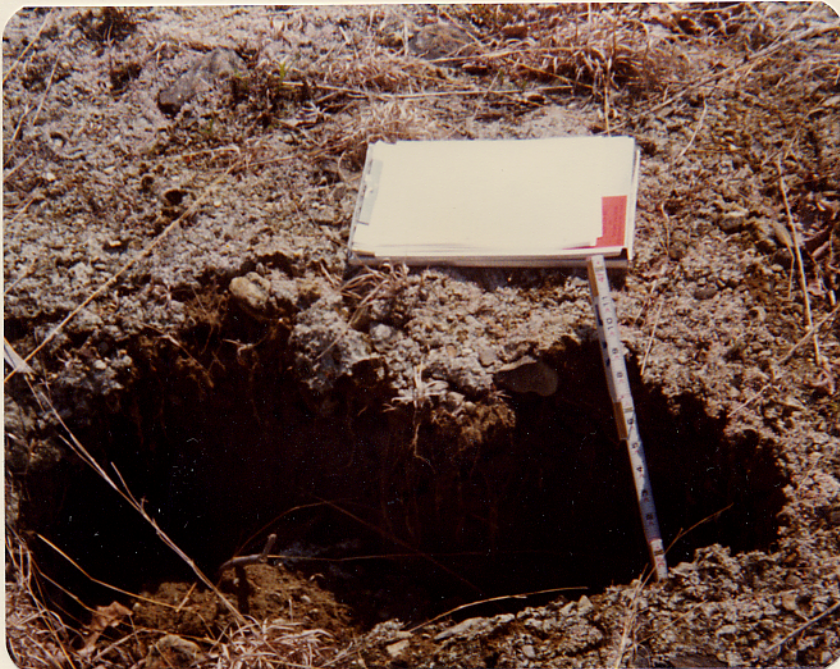
As discussed in Section 3, Visual Inspection, the dam is in fair condition. Seepage was observed along the downstream toe of the embankment. Sinkholes were observed at the toe of the upper downstream slope. Erosion of the earthfill has occurred along the walls of the stilling basin. Some small trees are growing on the bench and lower downstream slope of the dam.

NO. 6 SINKHOLE AT TOE OF UPPER DOWNSTREAM SLOPE

- a. Evaluate the stability of the dam, including an investigation of the seepage noted at the toe of the embankment and an investigation of the sinkholes on the downstream slope of the embankment.
- b. Make recommendations on repairing the leakage near the bottom of the spillway shaft and through the joints in the concrete outlet pipe. This should include an inspection of the spillway under a no flow condition.

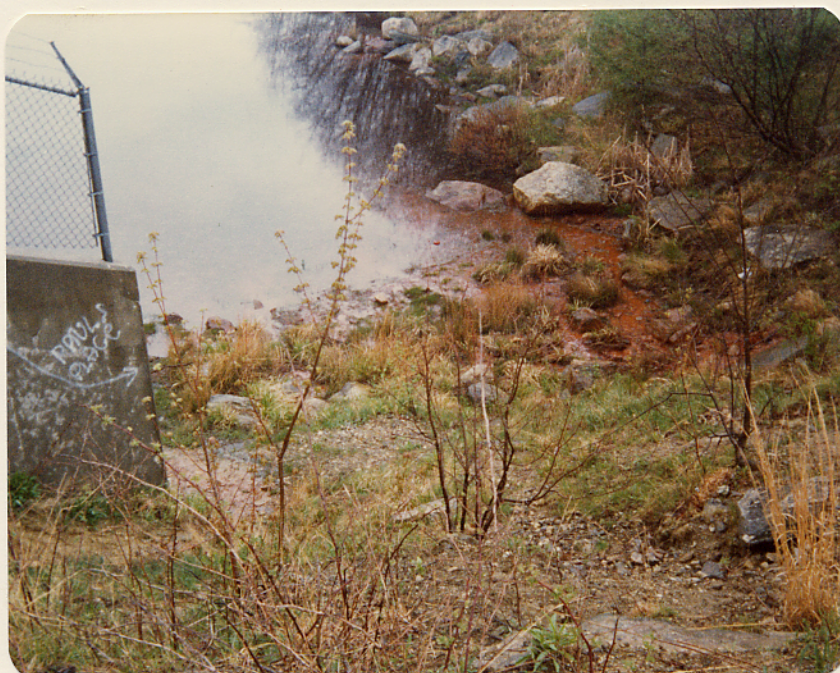
- a. General. The Phase I Inspection of the dam at Perley Brook Reservoir was performed on May 12, 1980. A copy of the inspection checklist is included in Appendix A. Previous inspections were conducted by the Worcester County Engineer's Office from 1965 to 1968. Copies of those reports are given in Appendix B. Selected photographs taken during the Visual Inspection are included in Appendix C.
- b. Dam. The dam is an earthfill structure with a morning glory spillway, and a low-level outlet. Evidence of seepage was noted at 7 locations near the downstream toe of the dam. The seepage is indicated by streams of water containing red sediment and flowing at an average rate of 1 gpm (see Photo No. 7).

NO. 7 VIEW OF SEEPAGE AREA AT DOWNSTREAM TOE

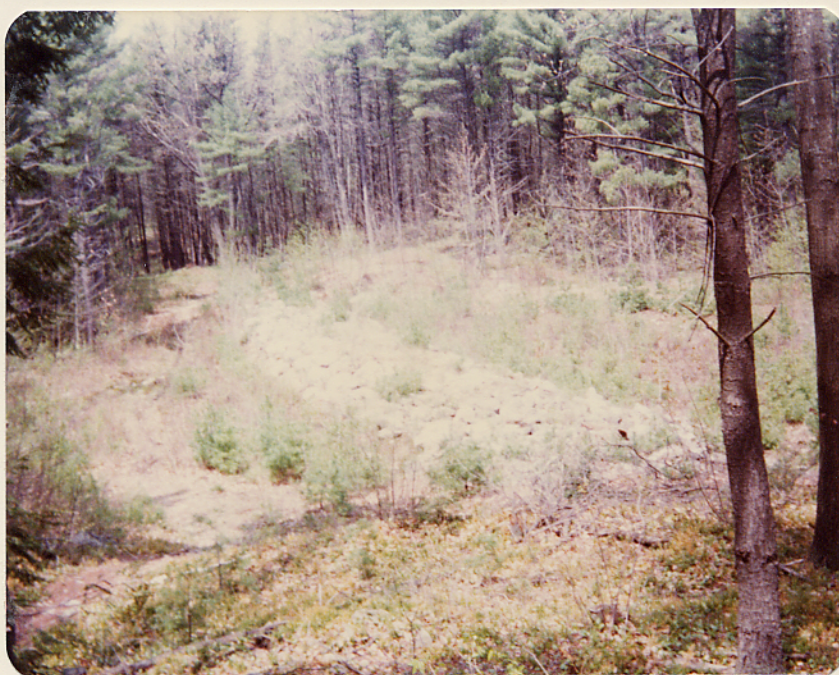
NO. 8 VIEW OF DIKE NO. 4
